**Flood Control Project Maintenance
Levee Inspections**
LMA District Cover Sheet
Spring 2019 Levee Inspection Results

Reclamation District No. 2104 Peters Pocket Tract

Levee Inspection Report By Mile - Spring 2019

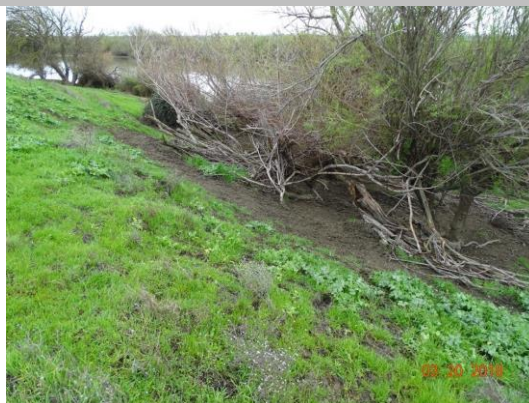
Photo 1 of 1 : SP_2019_RD2104_249_23_20190311_00012.jpg

LM Start	1.27	Rating **	M	Issue No.	23
LM End	1.27	Issue Type +	Ma	Location *	WS
Category	Earthen Levee			GPS Latitude/Longitude	
				Start	End
Item	Slope Stability			38.296182 °	38.296182 °
				-121.744318 °	-121.744318 °
DWR ID	DWR_RD2104_01_f_2016_23				
Comment Code					
S2 : Repair the levee slope damaged by foot traffic and prevent access where possible.					
Inspector Comment					
Repair the slope damaged by cows and trim up the tree limbs partially blocking the erosion site.

Spring 2018 - Trees should be trimmed and deadwood removed, and erosion from cattle repaired.

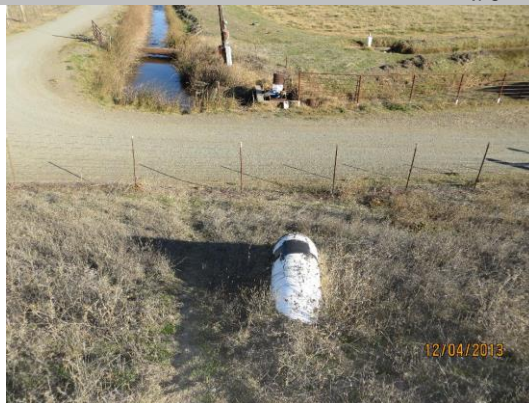
Photo 1 of 3 : UCIP_SP_2019_24984_45042.jpg

Comment Code					
Inspector Comment					
FS_ID:24984 DS_ID:24711 EP_NO: 10185 Repair Type: No Action Needed Crossing Status: Found UCIP Comments: 09/14/2017 Permit is unavailable, missing page 3 official permit documentation. (DWR UCIP - O. Magana) FIELD_STRUCT_DESC: 16-inch steel drainage pipe through the levee, 5.7 feet below the crown. Pump in an irrigation ditch on the landside (LS). Siphon breaker on the waterside (WS) slope. (Automatic Board Order (ABO) issued as Permit No. 10185, 1964 - Erwin E. and Lucy G. Vasser, limited details available electronic permit unavailable). [Additional Reference(s): DWR Levee Log, 2006. USACE Sacramento O&M Manual 108, April 1964, (HLM 1.52), Drawing Nos. 50-04-1977 and 50-04-3379]. FS Date: 12/4/2013

Pipe on LS slope with pump in irrigation ditch off LS toe visible in background.

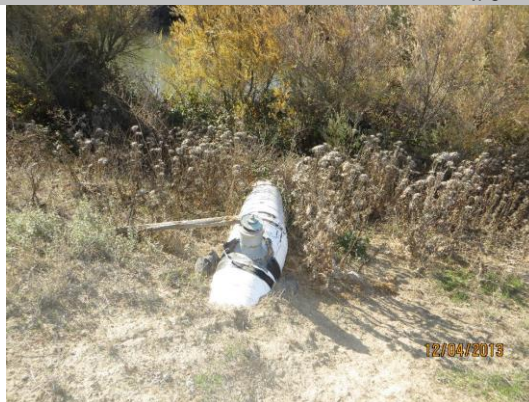
Photo 2 of 3 : UCIP_SP_2019_24984_45041.jpg

Siphon breaker on pipe at WS slope.

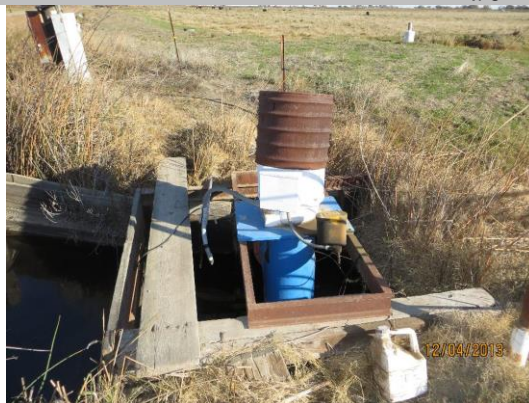
Photo 3 of 3 : UCIP_SP_2019_24984_45040.jpg

Comment Code						
Inspector Comment						
FS_ID:24984						
DS_ID:24711						
EP_NO: 10185						
Repair Type: No Action Needed						
Crossing Status: Found						
UCIP Comments: 09/14/2017 Permit is unavailable, missing page 3 official permit documentation. (DWR UCIP - O. Magana)						
FIELD_STRUCT_DESC: 16-inch steel drainage pipe through the levee, 5.7 feet below the crown. Pump in an irrigation ditch on the landside (LS). Siphon breaker on the waterside (WS) slope. (Automatic Board Order (ABO) issued as Permit No. 10185, 1964 - Erwin E. and Lucy G. Vasser, limited details available electronic permit unavailable).						
[Additional Reference(s): DWR Levee Log, 2006. USACE Sacramento O&M Manual 108, April 1964, (HLM 1.52), Drawing Nos. 50-04-1977 and 50-04-3379].						
FS Date: 12/4/2013

Pump in wooden distribution box off LS toe.

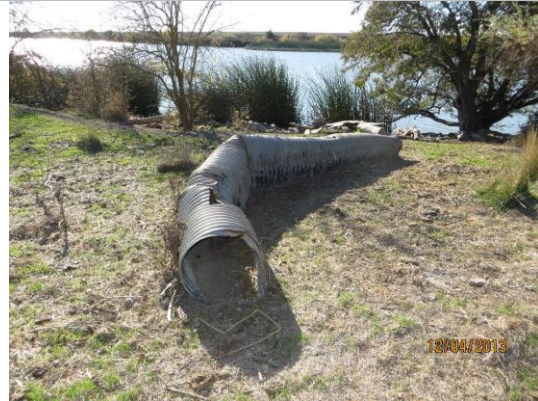
Photo 1 of 1 : UCIP_SP_2019_41347_45043.jpg

LM Start	2.40	Rating **	M	Issue No.	57	
LM End	2.40	Issue Type +	En	Location *		
Category	Supplemental			GPS Latitude/Longitude		
				Start	End	
Item	DWR UCIP Field Study			38.291579 °	38.291579 °	
				-121.726159 °	-121.726159 °	
DWR ID	24726					
Comment Code						
Inspector Comment						
FS_ID:41347						
DS_ID:24726						
EP_NO: N/A						
Repair Type: Non-Urgent						
Crossing Status: Indicator Found						
UCIP Comments: 24-inch CMP debris on WS berm may indicate pipe was abandoned.						
FIELD_STRUCT_DESC: *ABANDONED* 24-inch corrugated metal drainage pipe through the levee, 18 feet below the crown. Flap gate on the waterside (WS) toe. [Additional Reference(s): USACE Sacramento O&M Manual 108, April 1964, (HLM 2.60)].						
FS Date: 12/4/2013

Pipe debris on WS berm.

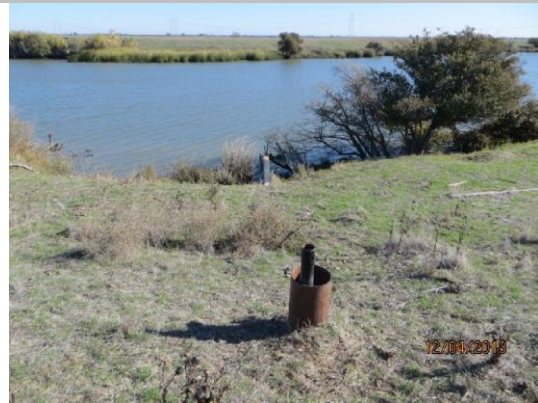
Photo 1 of 2 : UCIP_SP_2019_24990_45047.jpg

Comment Code					
Inspector Comment					
FS_ID:24990 DS_ID:24708 EP_NO: 10185 Repair Type: No Action Needed Crossing Status: Found UCIP Comments: 09/14/2017 Permit is unavailable, missing page 3 official permit documentation. (DWR UCIP - O. Magana) FIELD_STRUCT_DESC: 12-inch steel drainage pipe through the levee, 4 feet below the crown. Pump on pile structure in drainage canal on the landside (LS). Siphon breaker in a 12-inch steel riser on the waterside (WS) slope. (Automatic Board Order (ABO) issued as Permit No. 10185, 1964 - Erwin E. and Lucy G. Vasser, limited information available electronic version of permit missing. Replaced under Permit No. 4412, 1963 - Ervin E. and Lucy G. Vassar, limited details available electronic permit copy unavailable). [Additional Reference(s): DWR Levee Log, 2006. USACE Sacramento O&M Manual 108, April 1964, (HLM 3.12), Drawing No. 50-04-3379]. FS Date: 12/4/2013

Siphon breaker in steel riser on WS slope with pipe and flap gate visible in background at WS berm.

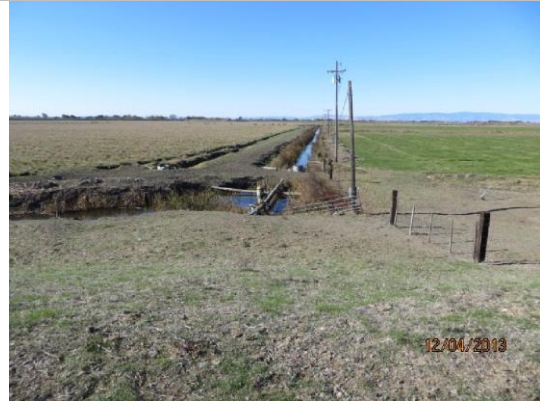
Photo 2 of 2 : UCIP_SP_2019_24990_45046.jpg

Comment Code					
Inspector Comment					
FS_ID:24990 DS_ID:24708 EP_NO: 10185 Repair Type: No Action Needed Crossing Status: Found UCIP Comments: 09/14/2017 Permit is unavailable, missing page 3 official permit documentation. (DWR UCIP - O. Magana) FIELD_STRUCT_DESC: 12-inch steel drainage pipe through the levee, 4 feet below the crown. Pump on pile structure in drainage canal on the landside (LS). Siphon breaker in a 12-inch steel riser on the waterside (WS) slope. (Automatic Board Order (ABO) issued as Permit No. 10185, 1964 - Erwin E. and Lucy G. Vasser, limited information available electronic version of permit missing. Replaced under Permit No. 4412, 1963 - Ervin E. and Lucy G. Vassar, limited details available electronic permit copy unavailable). [Additional Reference(s): DWR Levee Log, 2006. USACE Sacramento O&M Manual 108, April 1964, (HLM 3.12), Drawing No. 50-04-3379]. FS Date: 12/4/2013

Pump on pier in ditch off LS toe.

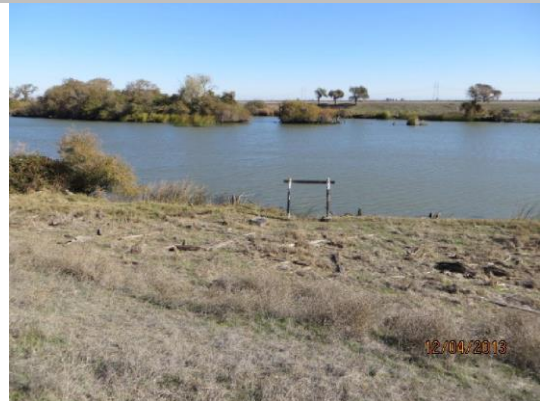
Photo 1 of 3 : UCIP_SP_2019_41834_45069.jpg

LM Start	3.04	Rating **	M	Issue No.	59
LM End	3.04	Issue Type +	En	Location *	
Category	Supplemental			GPS Latitude/Longitude	
				Start	End
Item	DWR UCIP Field Study			38.299447 °	38.299447 °
				-121.730444 °	-121.730444 °
DWR ID	24720				
Comment Code					
Inspector Comment					
FS_ID:41834 DS_ID:24720 EP_NO: 14184 Repair Type: Non-Urgent Crossing Status: Found UCIP Comments: Signs in disrepair and need proper markings. FIELD_STRUCT_DESC: 6-inch steel gas line through the levee, 3 feet below the crown. Signs on both toes of the levee. FS Date: 12/4/2013

Sign on WS berm.

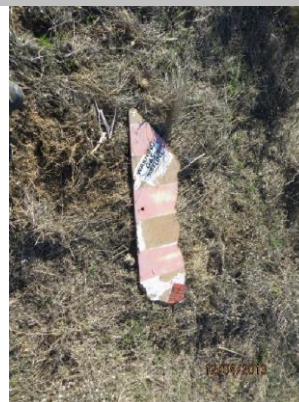
Photo 3 of 3 : UCIP_SP_2019_41834_45070.jpg

Broken sign marker on LS toe.

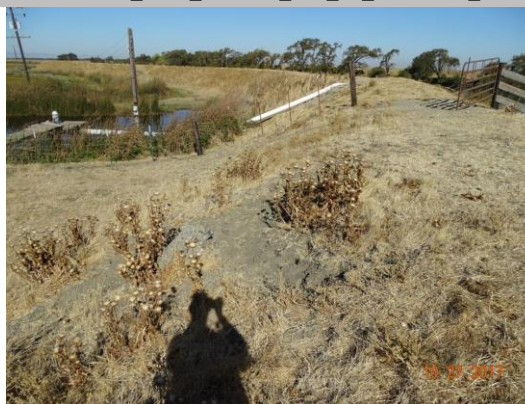
Photo 1 of 1 : SP_2019_RD2104_249_21_20190311_00010.jpg

LM Start	4.00	Rating **	M	Issue No.	21
LM End	4.00	Issue Type +	Ma	Location *	LS
Category	Earthen Levee			GPS Latitude/Longitude	
				Start	End
Item	Slope Stability			38.310672 °	38.310672 °
				-121.736155 °	-121.736155 °
DWR ID	DWR_RD2104_01_f_2018_21				
Comment Code					
S2 : Repair the levee slope damaged by foot traffic and prevent access where possible.					
Inspector Comment

Repair landside slope eroded by livestock, and prevent future erosion.

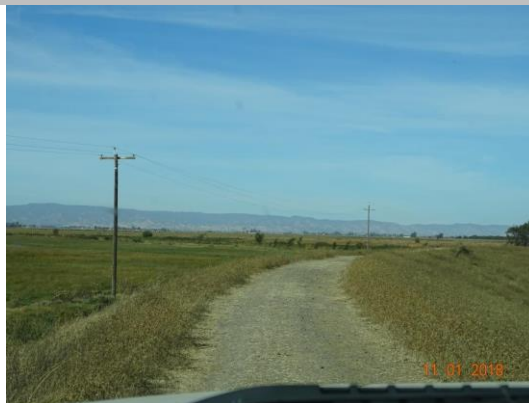
Photo 1 of 2 : SP_2019_RD2104_249_17_20190311_00007.jpg

View looking upstream at vegetation on the water side slope (November 2018).

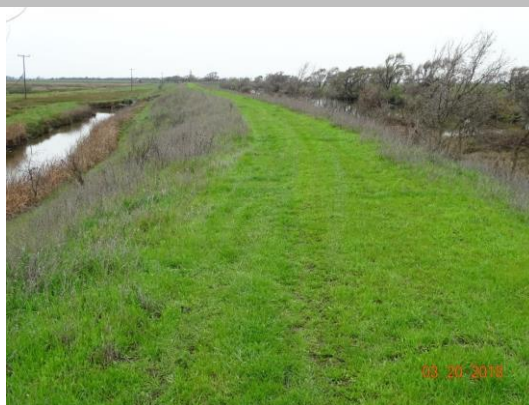
Photo 2 of 2 : SP_2019_RD2104_249_17_20190311_00008.jpg

LM Start	4.05	Rating **	M	Issue No.	17 (cont)
LM End	4.30	Issue Type +	Ma	Location *	WS

Waterside (right) vegetation should be managed to 20 feet from crown to allow inspection and access.

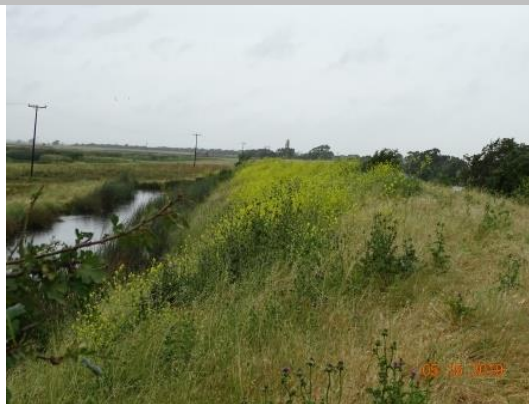
Photo 1 of 1 : SP_2019_RD2104_249_10_20190515_00051.jpg

LM Start	4.25	Rating **	U	Issue No.	10
LM End	4.30	Issue Type +	Ma	Location *	LS
Category	Earthen Levee			GPS Latitude/Longitude	
				Start	End
Item	Vegetation			38.313253 °	38.313822 °
				-121.739152 °	-121.739757 °
DWR ID	DWR_RD2104_01_s_2018_10				
Comment Code					
V2 : Remove the wild growth other than native grasses from the levee slopes.					
Inspector Comment

View looking upstream at wildgrowth on the landside slope (Spring 2019).

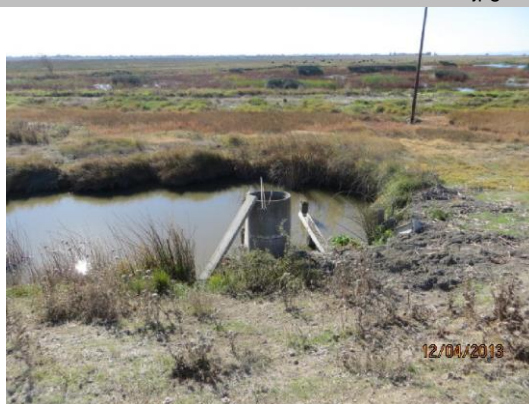
Photo 2 of 3 : UCIP_SP_2019_51459_45061.jpg

36-inch concrete riser on LS toe at channel.

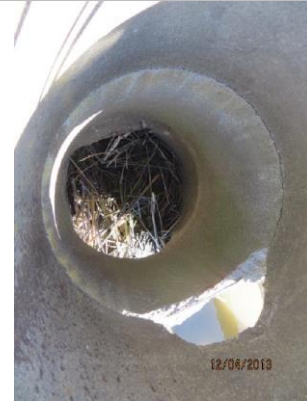
Photo 3 of 3 : UCIP_SP_2019_51459_45060.jpg

Item	DWR UCIP LMA Responsibility		38.313955 °	38.313955 °								
			-121.739930 °	-121.739930 °								
DWR ID	24705											
Comment Code												
Inspector Comment												
FS_ID:51459 DS_ID:24705 EP_NO: 10182 Repair Type: Non-Urgent Crossing Status: Found UCIP Comments: 12/06/2016 Crossing has been downgraded from "Urgent" to "Non-Urgent" no signs of leaks observed along pipe alignment (limited inspection on WS toe). According to LMA representative, this crossing was replaced 6 years ago (2010) at WS concrete apron. Recommend conducting internal inspection of pipe through the levee and LS to determine pipe integrity. (O. Magana - DWR UCIP) 12/04/2013 Vegetation and soil buildup throughout pipe preventing flapgate from closing. Remove vegetation to allow gate to close properly. (W. Wylie - DWR UCIP) FIELD_STRUCT_DESC: 24-inch corrugated metal drainage pipe through the levee, 15 feet below the crown. 36-inch concrete standpipe on the landside (LS) toe. Flap gate on the waterside (WS) toe. Two corrugated metal cutoff walls installed. (24-inch pipe [HLM 4.65] authorized under Automatic Board Order (ABO) issued as Permit No. 10182, 1974 - Julia Trust Machado). [Additional Reference(s): DWR Levee Log, 2006. USACE Sacramento O&M Manual 108, April 1964, (HLM 4.65), Drawing No. 50-04-3379]. FS Date: 12/6/2016

36-inch concrete riser with vegetation buildup inside.

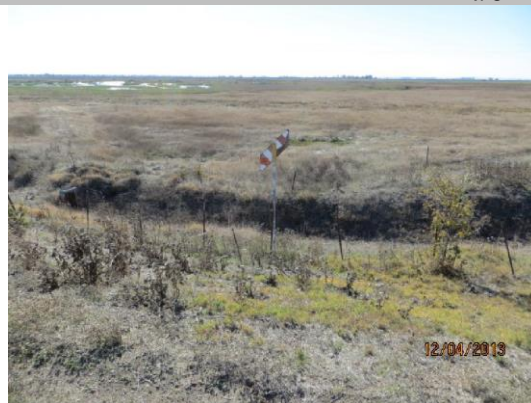
Photo 1 of 2 : UCIP_SP_2019_25003_45081.jpg

LM Start	4.65	Rating **	M	Issue No.	62
LM End	4.65	Issue Type +	En	Location *	
Category	Supplemental			GPS Latitude/Longitude	
				Start	End
Item	DWR UCIP Field Study			38.317941 °	38.317941 °
				-121.743503 °	-121.743503 °
DWR ID	24704				
Comment Code					
Inspector Comment					
FS_ID:25003					
DS_ID:24704					
EP_NO: 10182					
Repair Type: Non-Urgent					
Crossing Status: Found					
UCIP Comments: Sign on WS toe needs reperi.					
FIELD_STRUCT_DESC: 8-inch steel gas line through the levee, at the high elevation. Signs on both toes of the levee. (Automatic Board Order (ABO) issued as Permit No. 10182, 1974 - Julia Trust Machado).					
[Additional Reference(s): DWR Levee Log, 2006. USACE Sacramento O&M Manual 108, April 1964, Drawing No. 50-04-3379].					
FS Date: 12/4/2013

Gasline marker on LS toe.

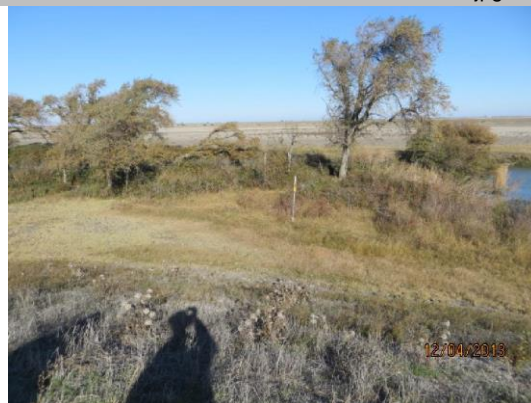
Photo 2 of 2 : UCIP_SP_2019_25003_45080.jpg

Sign pole on WS toe missing sign.

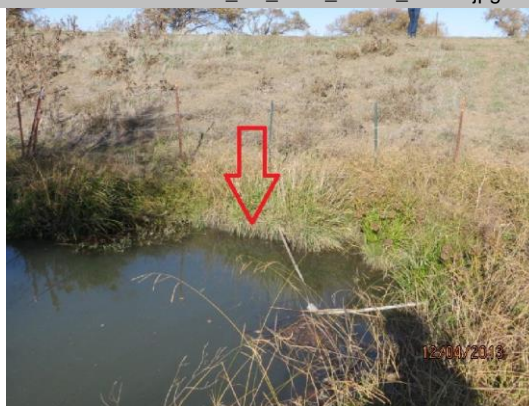
Photo 1 of 2 : UCIP_SP_2019_25005_45083.jpg

Comment Code						
Inspector Comment						
FS_ID:25005 DS_ID:24703 EP_NO: N/A Repair Type: Non-Urgent Crossing Status: Found UCIP Comments: Good candidate for video inspection. FIELD_STRUCT_DESC: 18-inch steel irrigation pipe through the levee, 13.5 feet below the crown. Pump on pile structure in the stream. Slide gate in a 36-inch corrugated metal pipe (CMP) riser on the waterside (WS) slope. Two cutoff walls. Concrete U-shaped headwall and air vent at the landside (LS) toe. Electrical conduit through the levee at the same location. [Additional Reference(s): DWR Levee Log, 2006. USACE Sacramento O&M Manual 108, April 1964, (HLM 5.06), Drawing No. 50-04-3379]. FS Date: 12/4/2013

Concrete headwall on LS toe at irrigation ditch.

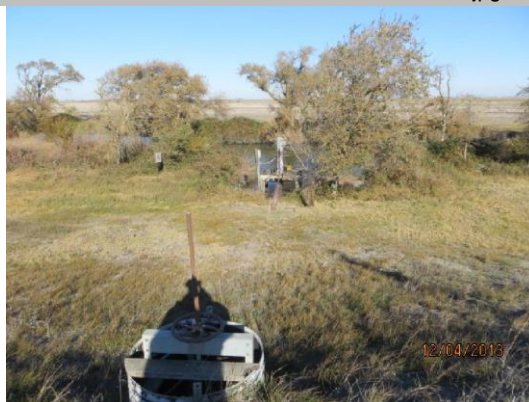
Photo 2 of 2 : UCIP_SP_2019_25005_45082.jpg

Slide gate in CMP riser on WS slope with pump on pier in background.

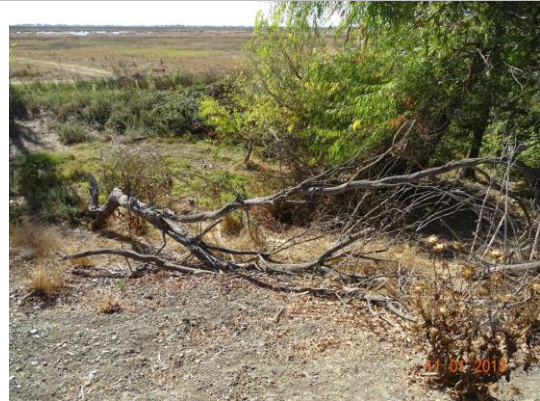
Photo 1 of 1 : SP_2019_RD2104_249_31_20190311_00016.jpg

View of down tree limb on the land side slope (November 2018).

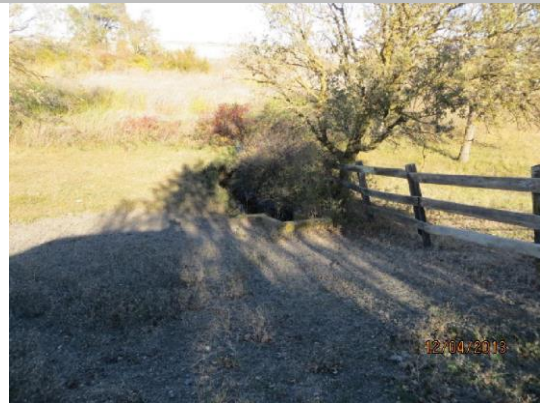
Photo 1 of 3 : UCIP_SP_2019_25006_45086.jpg

LM Start	4.72	Rating **	M	Issue No.	64	
LM End	4.72	Issue Type +	En	Location *		
Category	Supplemental			GPS Latitude/Longitude		
				Start	End	
Item	DWR UCIP Field Study			38.318432 °	38.318432 °	
				-121.744540 °	-121.744540 °	
DWR ID	24702					
Comment Code						
Inspector Comment						
FS_ID:25006 DS_ID:24702 EP_NO: 10182 Repair Type: Non-Urgent Crossing Status: Found UCIP Comments: Minor erosion of base under headwall on WS toe. Heavy corrosion of pipe at WS toe. Further evaluation of pipe integrity needed. FIELD_STRUCT_DESC: 24-inch corrugated metal drainage pipe through the levee, 13.5 feet below the crown. Concrete U-shaped headwalls on both ends. Two corrugated metal cutoff walls. Flap gate on the waterside (WS) end. (Automatic Board Order (ABO) issued as Permit No. 10182, 1974 - Julia Trust Machado). [Additional Reference(s): DWR Levee Log, 2006]. FS Date: 12/4/2013

Concrete U shaped headwall on WS toe.

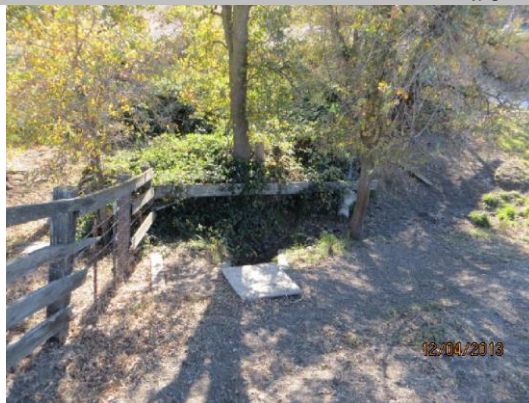
Photo 2 of 3 : UCIP_SP_2019_25006_45085.jpg

Comment Code						
Inspector Comment						
FS_ID:25006 DS_ID:24702 EP_NO: 10182 Repair Type: Non-Urgent Crossing Status: Found UCIP Comments: Minor erosion of base under headwall on WS toe. Heavy corrosion of pipe at WS toe. Further evaluation of pipe integrity needed. FIELD_STRUCT_DESC: 24-inch corrugated metal drainage pipe through the levee, 13.5 feet below the crown. Concrete U-shaped headwalls on both ends. Two corrugated metal cutoff walls. Flap gate on the waterside (WS) end. (Automatic Board Order (ABO) issued as Permit No. 10182, 1974 - Julia Trust Machado). [Additional Reference(s): DWR Levee Log, 2006]. FS Date: 12/4/2013

Concrete U shaped headwall on LS toe.

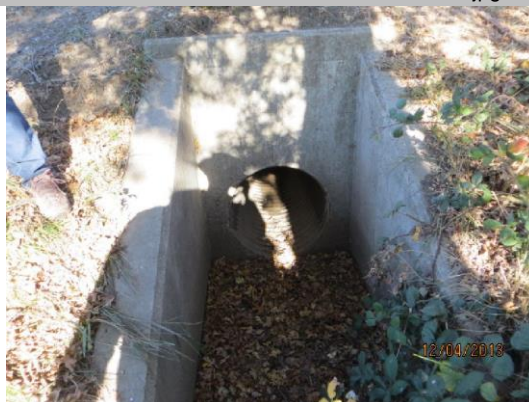
Photo 3 of 3 : UCIP_SP_2019_25006_45084.jpg

Concrete U shaped headwall on LS toe.

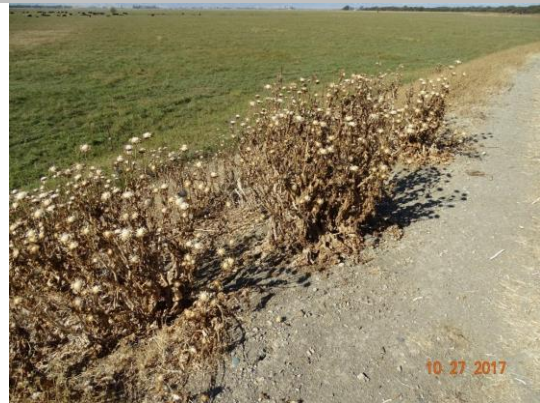
Photo 1 of 1 : SP_2019_RD2104_249_24_20190311_00013.jpg

LM Start	4.96	Rating **	U	Issue No.	24
LM End	4.96	Issue Type +	Ma	Location *	LS
Category	Earthen Levee			GPS Latitude/Longitude	
				Start	End
Item	Slope Stability			38.320382 °	38.320382 °
				-121.748155 °	-121.748155 °
DWR ID	DWR_RD2104_01_f_2017_24				
Comment Code					
S1 : Repair slope instability.					
Inspector Comment

Landside levee slope has slumped leaving a 2-foot vertical scarp at the shoulder. Site should be repaired.

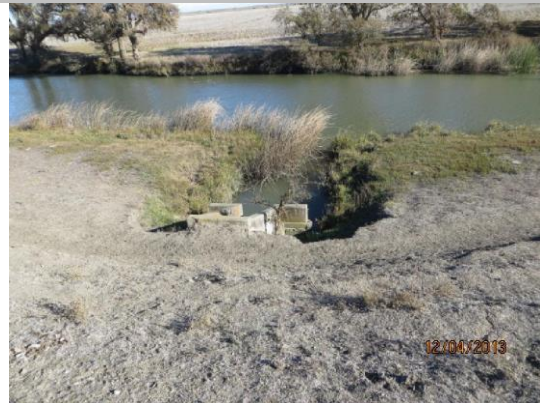
Photo 1 of 3 : UCIP_SP_2019_53387_45090.jpg

Comment Code						
Inspector Comment						
FS_ID:53387 DS_ID:24701 EP_NO: 10182 Repair Type: Urgent Crossing Status: Found UCIP Comments: 10/12/2018 Same as last inspection; concrete headwall on WS still being undermined so crossing remains Urgent (D. Sanoski - DWR UCIP).12/06/2016 same as last inspection--pipe remains "Urgent" CMP shows holes through wall and concrete headwall is undermined. Need to contact owner. Owner will need to work with the CVFPB to comply with Title 23. (O. Magana - DWR UCIP)12/04/2013 Footing under headwall on WS toe severely undermined. Pipe rusted heavily with holes at WS and may need replacement. (W. Wylie - DWR UCIP) FIELD_STRUCT_DESC: 24-inch corrugated metal drainage pipe through the levee, 13 feet below the crown. Two cutoff walls. Concrete U-shaped headwalls on both ends. Flap gate on the waterside (WS). (24-inch pipe [HLM 5.50] authorized under Automatic Board Order (ABO) issued as Permit No. 10182, 1974 - Julia Trust Machado). [Additional Reference(s): DWR Levee Log, 2006. USACE Sacramento O&M Manual 108, April 1964, (HLM 5.5), listed as a 12-inch pipe, Drawing No. 50-04-3379, listed as an 18-inch pipe]. FS Date: 10/12/2018 5:06:00 PM

Concrete U-shaped headwall on WS toe. Note erosion scarp around headwall.

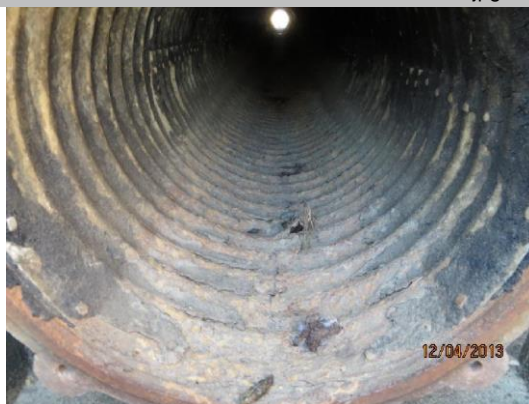
Photo 3 of 3 : UCIP_SP_2019_53387_45088.jpg

Corrosion through pipe with holes on WS toe.

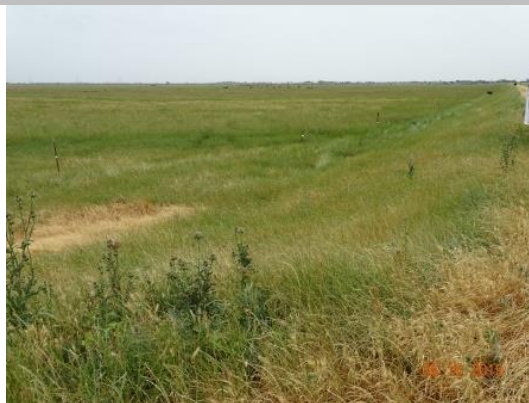
Photo 1 of 1 : SP_2019_RD2104_249_39_20190515_00046.jpg

View looking downstream at annual vegetation on the landside slope (Spring 2019).

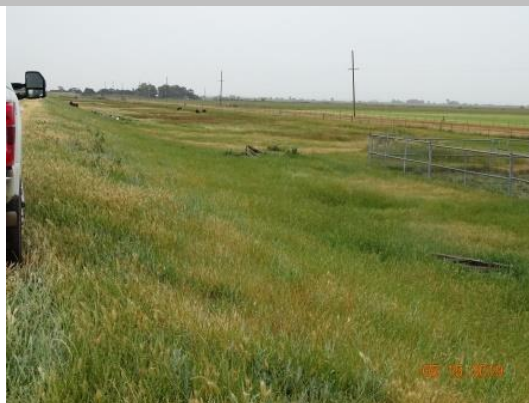
Photo 1 of 2 : SP_2019_RD2104_249_43_20190515_00047.jpg

View looking downstream at annual vegetation on the waterside slope (Spring 2019).

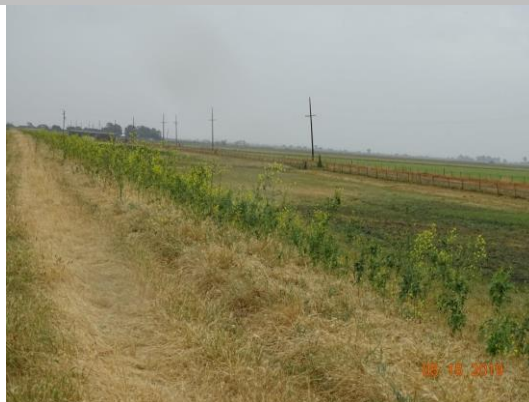
Photo 2 of 2 : SP_2019_RD2104_249_43_20190520_00054.jpg

LM Start	5.22	Rating **	M	Issue No.	43 (cont)
LM End	6.84	Issue Type +	Ma	Location *	WS

View looking downstream at annual vegetation on the waterside slope (Spring 2019).

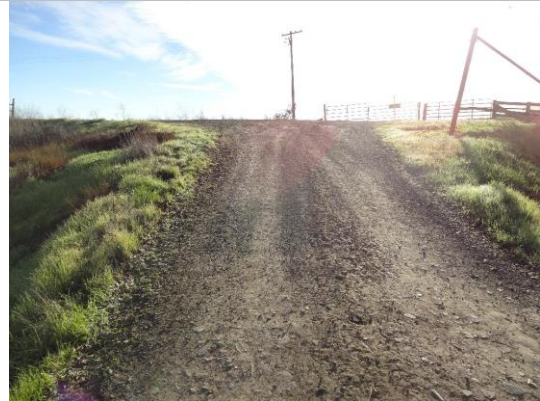
Photo 1 of 3 : UCIP_SP_2019_53385_76913.jpg

No signs present at ramp to enter RD2104.

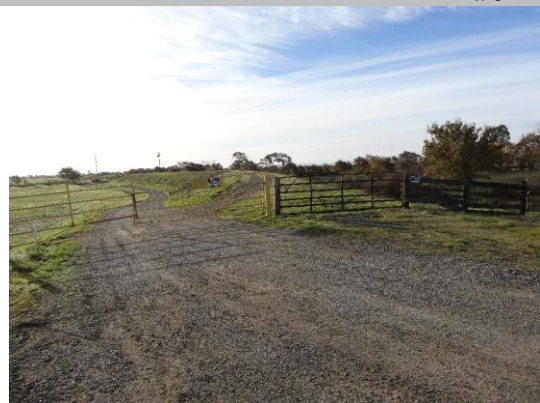
Photo 2 of 3 : UCIP_SP_2019_53385_76914.jpg

No signs present of gas line.
